**Caroga Lake Public Campground**

**Unit Management Plan**

**PROPOSED FINAL**

Town of Caroga - Fulton County, New York

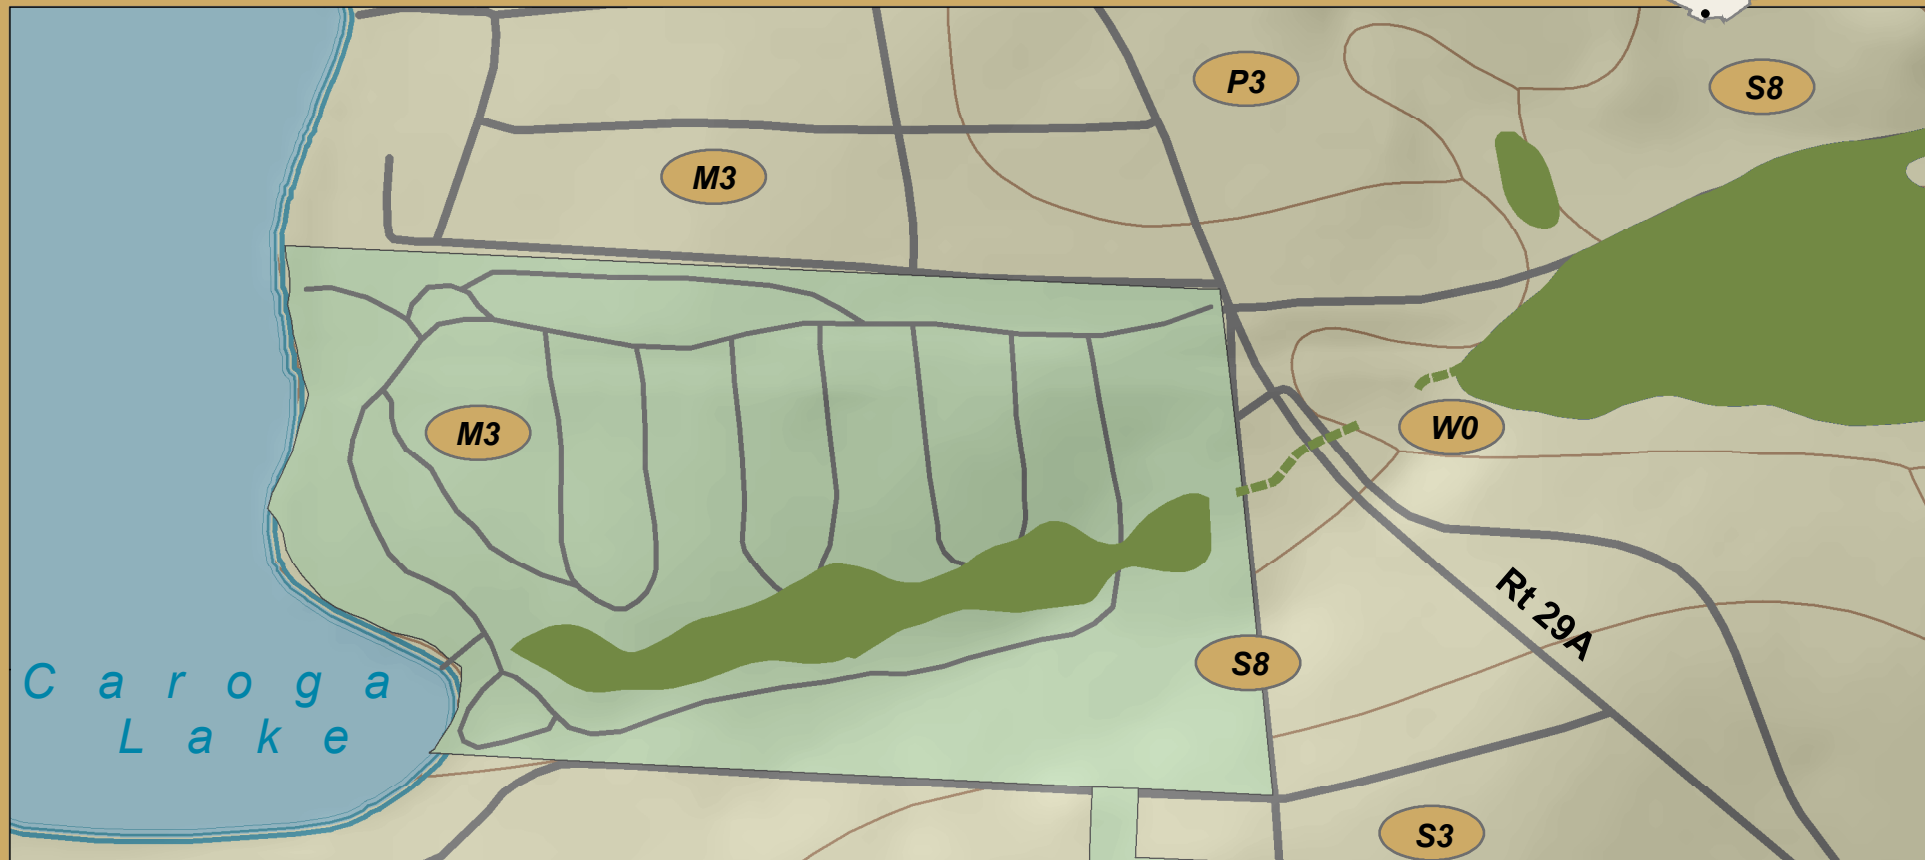
Exhibit # 10 - Wetlands and Soils Map

Soils found within Caroga Lake Campground's boundaries are 41.2 acres (84%) Metacomet fine sandy loam, 3-8% slopes; 6.8 acres (14%) of Skerry fine sandy loam, 8-15% slopes in the southern part of the campground; and 1.1 acres (2%) of Skerry fine sandy loam, 3-8% slopes in the extreme southeast corner of the campground. (See Exhibit 10.)

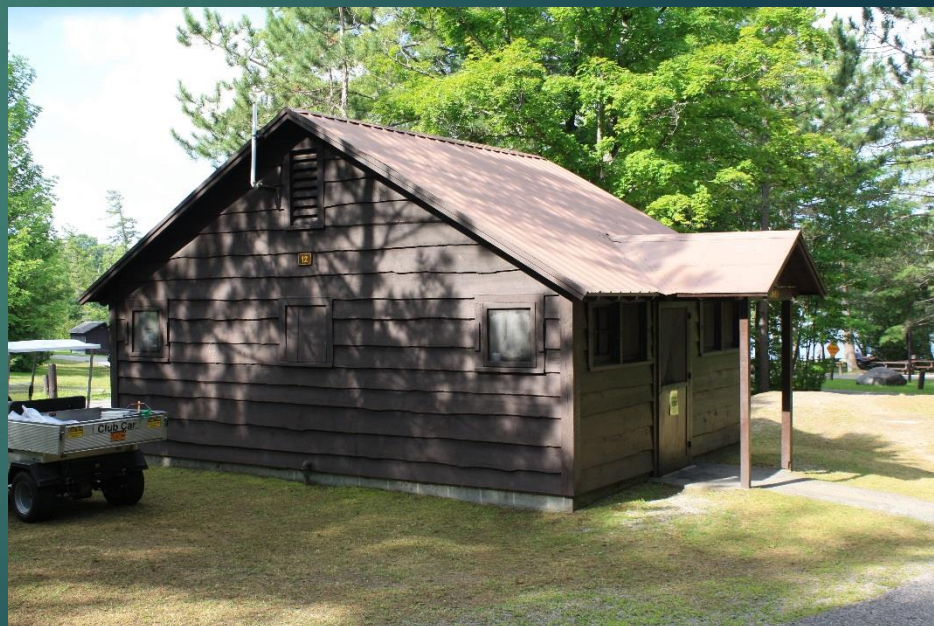
Comfort Station #1 (Bldg 12)

The existing toilet buildings contain older style toilets which require constant maintenance, and replacement parts are no longer available for the leaking flush valves. Toilet building #13 is located in the vicinity of the one existing ADA campsite and the three sites proposed for conversion to universal access. This area is level and best suited for an ADA-compliant toilet building. A new accessible toilet building will improve efficiency and meet the needs of all campers. Toilet building #12 is used by both

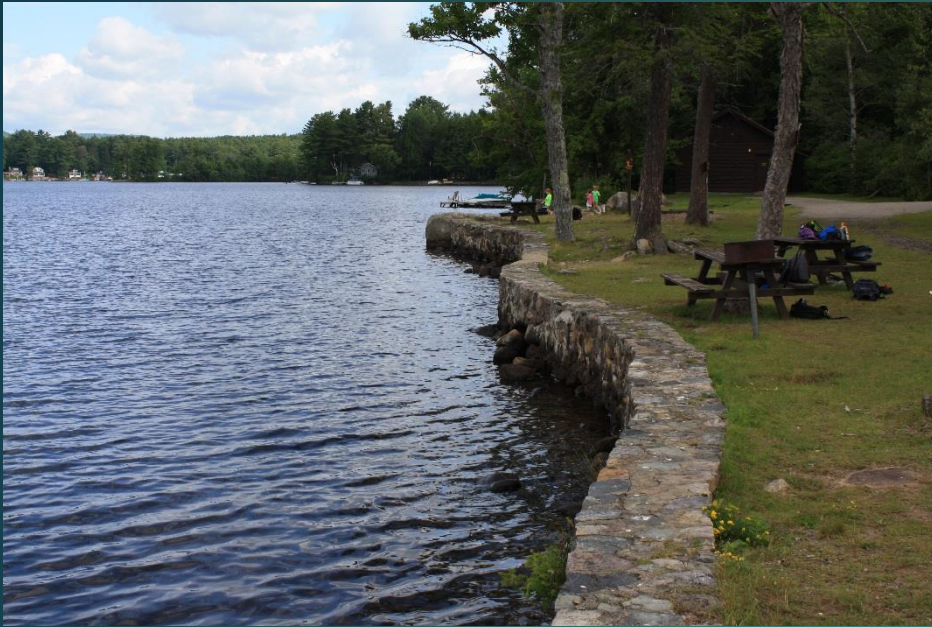
Lakeshore Retaining Wall

The stone seawall was constructed in 1929 and prevents shoreline erosion. The wall is in good condition but needs some pointing up of the stonework and additional soil brought in for where areas behind the wall have settled. If the wall has a significant failure in the future, the department will consider a more natural shoreline stabilization remedy rather than replacement of the retaining wall.

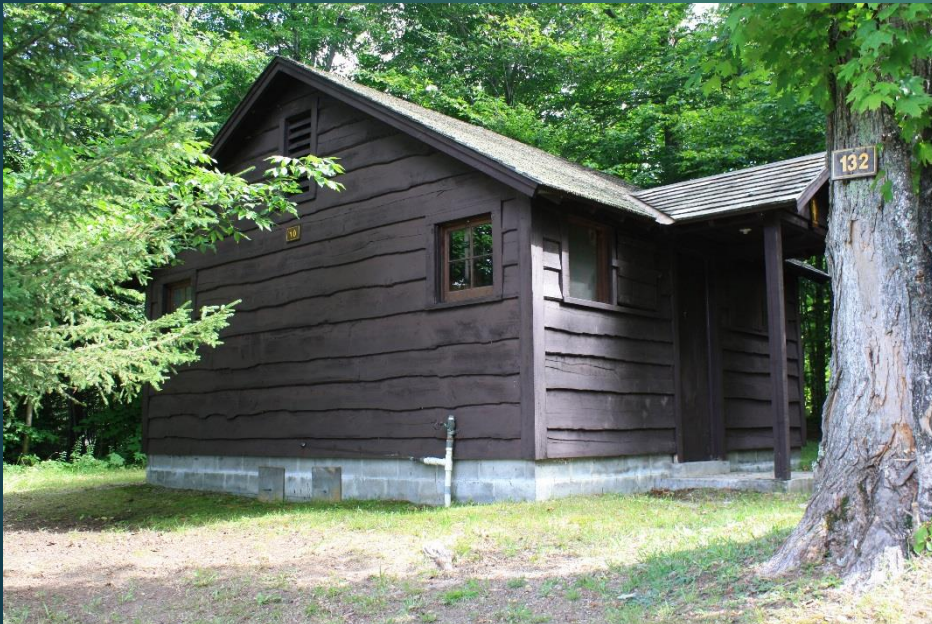
Comfort Station #2 –Vault (Bldg 10)

The vault toilet (building #10), located near the day-use area, is no longer used because it was determined to have a leak in its vault. If a temporary storage tank can be located outside the building and connected, it could be used as a backup toilet building in the event of a power outage. At such time when a backup power system is installed (management action #3), the toilet could be removed and the building could be converted to a storage building.
